## ANNEX 2 – Diaphragm Units

### Annex 2.1 - General Information

**Annex 2.2 – Manufacturer: Edson International  
Model: 284EB-40 (Diaphragm)**

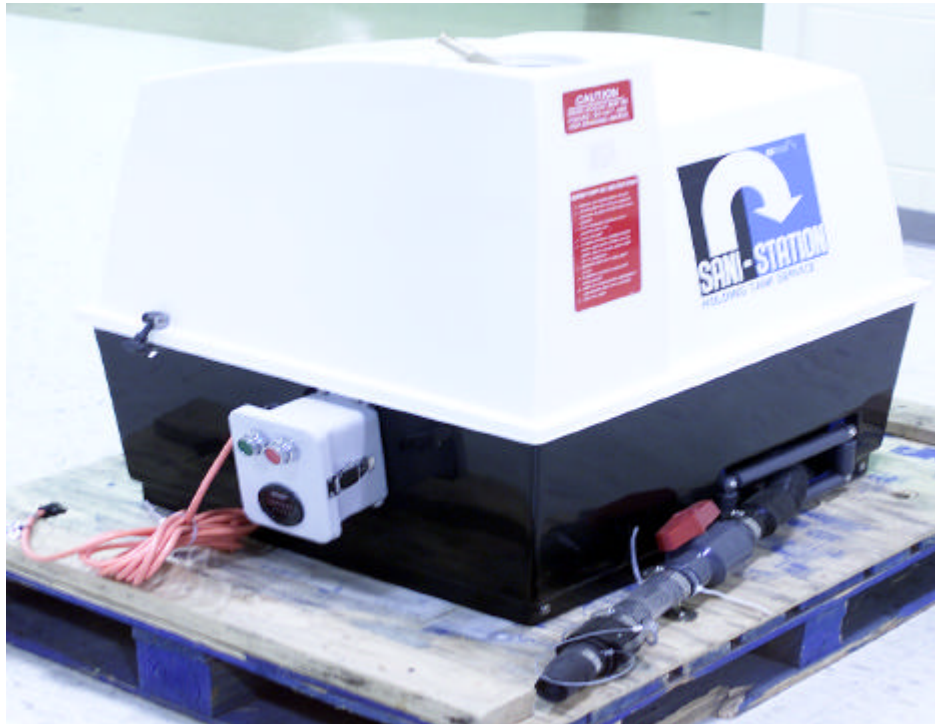
**External View**

Construction: Cast Iron Pump Body (treated with rust inhibitor and painted)  
 Rubber Diaphragm (with cord reinforcement)  
 Neoprene Valves (with cord reinforcement)  
 Stainless Steel Hardware  
 Steel Frame (primed and painted)  
 Inlet – 2” Male NPT  
 Discharge – 2” Male NPT  
 Molded Solid Fiberglass Enclosure

The Exstar International Sani-Station SS-100 Deluxe Pump-Out unit operated for 159.6 hours in the life-cycle testing set-up. During this time period, the unit suffered three failures (See *Summary of Repairs* on page 43). The failures occurred due to the large stresses that were generated on the unit by the combination of the suction lift and discharge head that the unit was exposed to in the test set-up. After consultation with the manufacturer concerning these failures, Exstar International chose to remove the unit from the study.

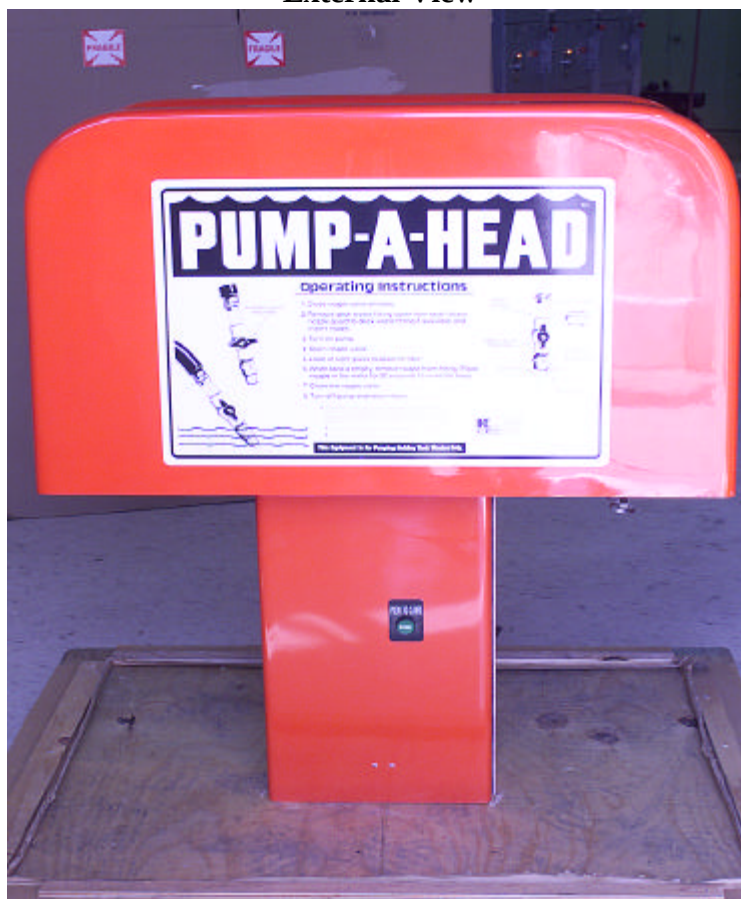
**External View**

Construction: Cast Iron Pump Body  
Nitrile Diaphragm and Valves  
Stainless Steel Hardware  
Painted Steel Frame (zinc-based primer used for corrosion resistance)  
Molded Solid Fiberglass Enclosure

1. The Keco Model PAH-175 as originally submitted failed during the initial test runs with water. The connecting pin on the speed reducer failed due to large stresses on the operating mechanism. A representative of Keco made a site visit to UL and modified the pump-out unit by installing a vacuum relief valve on the suction piping of the unit. This modification allowed a small amount of air to be introduced into the suction of the pump during operation and this reduced the differential pressure across the pump and reduced the stress on the operating mechanism of the pump.
  2. The Keco Model PAH-175 (modified) operated for 834.7 hours in the life-cycle testing set-up. During this time period, the unit suffered four failures (See *Summary of Repairs* on page 46).
-
